# SR 2 KIRKWOOD HIGHWAY

## PEDESTRIAN SAFETY STUDY

## FINAL REPORT

JANUARY 2015

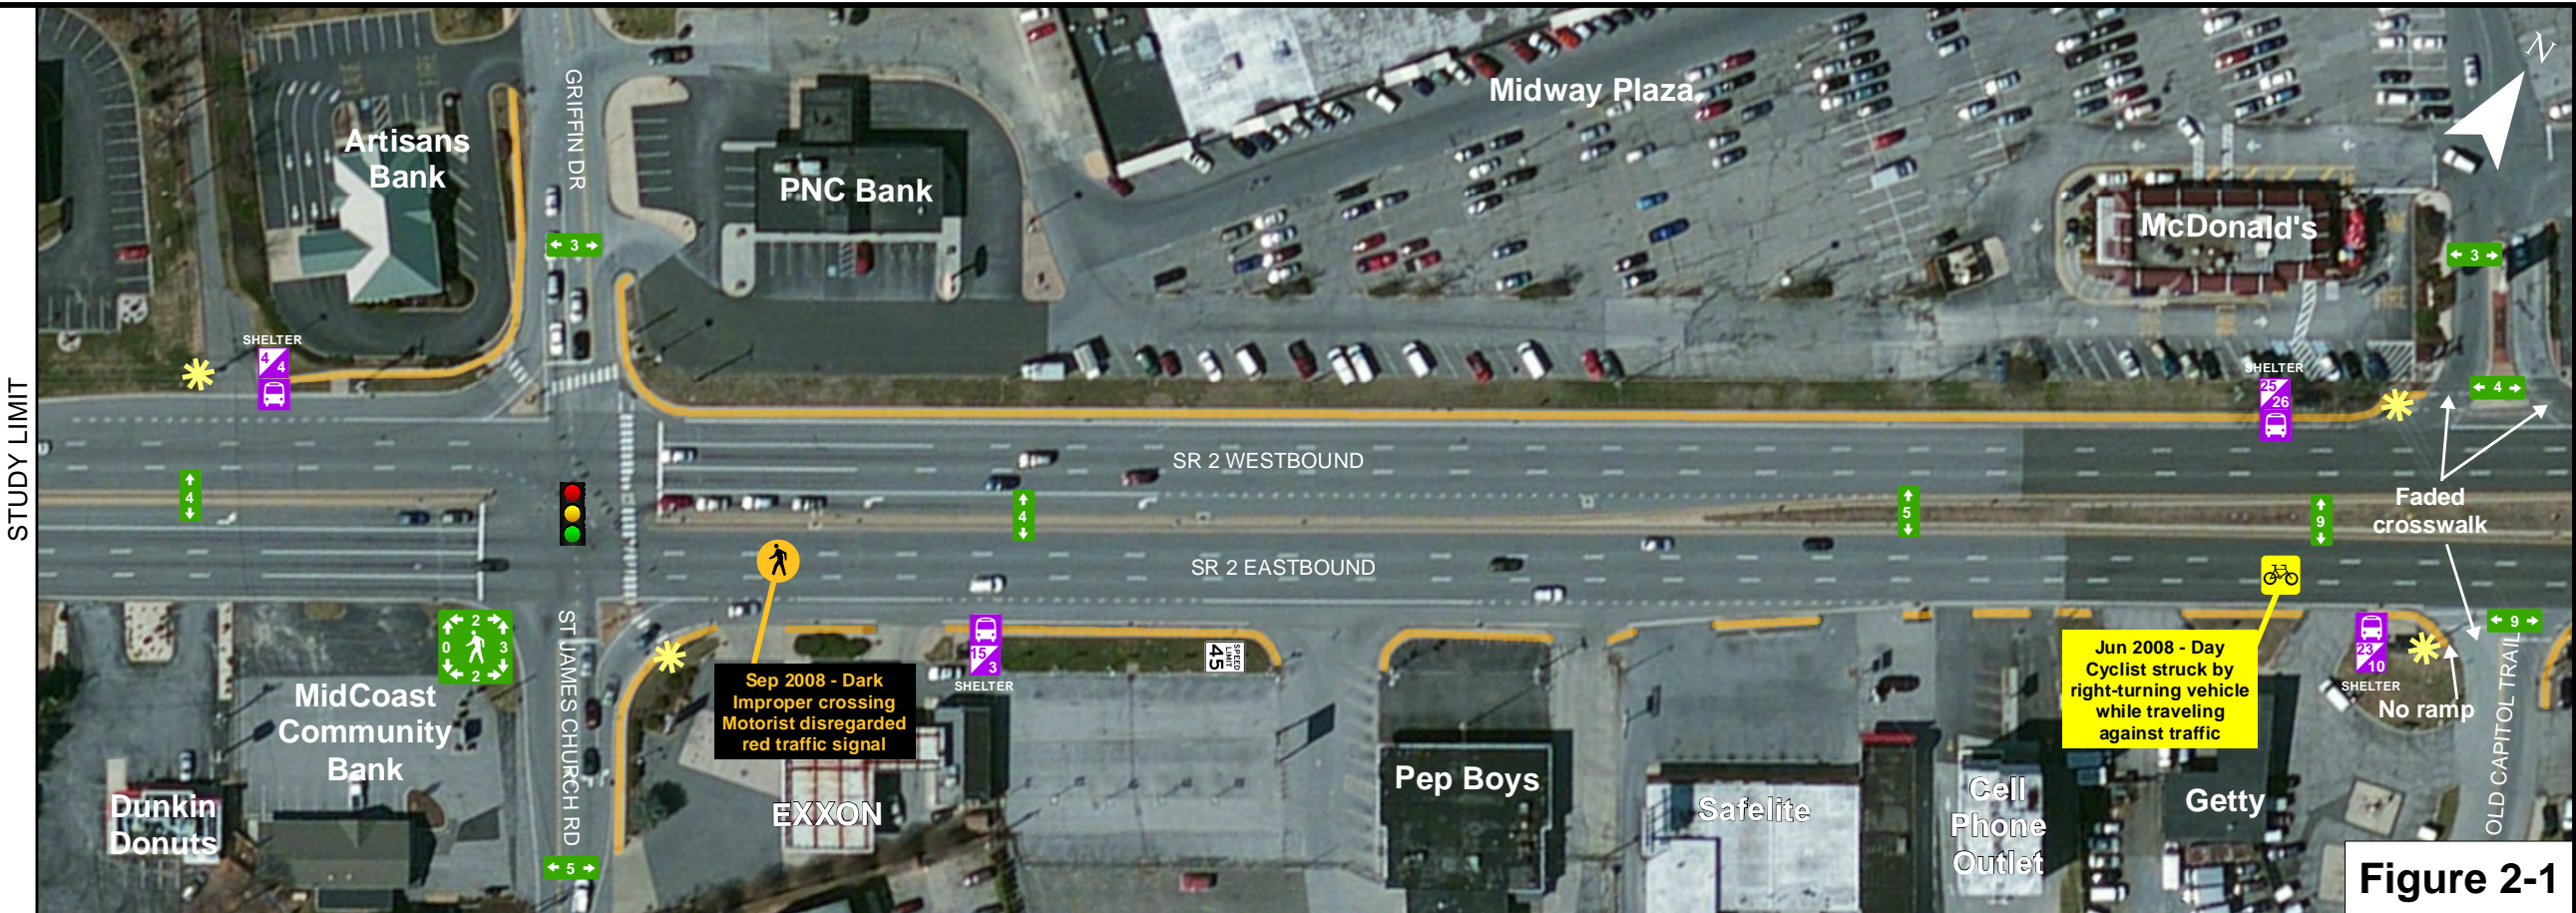
Figure 2-1

- Pedestrian Non-Injury Crash
- Bicycle Non-Injury Crash
- Pedestrian Injury Crash
- Bicycle Injury Crash
- Pedestrian Fatal Crash
- Bicycle Fatal Crash
- Nighttime Crash
- Average Hourly Ped Volume (highest of 3 peaks)

Crash study period - January 2005  
through December 2012

Existing condition figures for the SR 2 corridor from St. James Church Road/Griffin Drive to SR 141 are shown in **Figures 2-1 to 2-12**. The following information is included in the existing condition figures. In addition, further discussion of existing conditions is provided below. It is important to note that the lighting locations shown in the figures include only roadway lighting provided along SR 2 (i.e., ambient lighting due to adjacent properties is not shown on the figures).

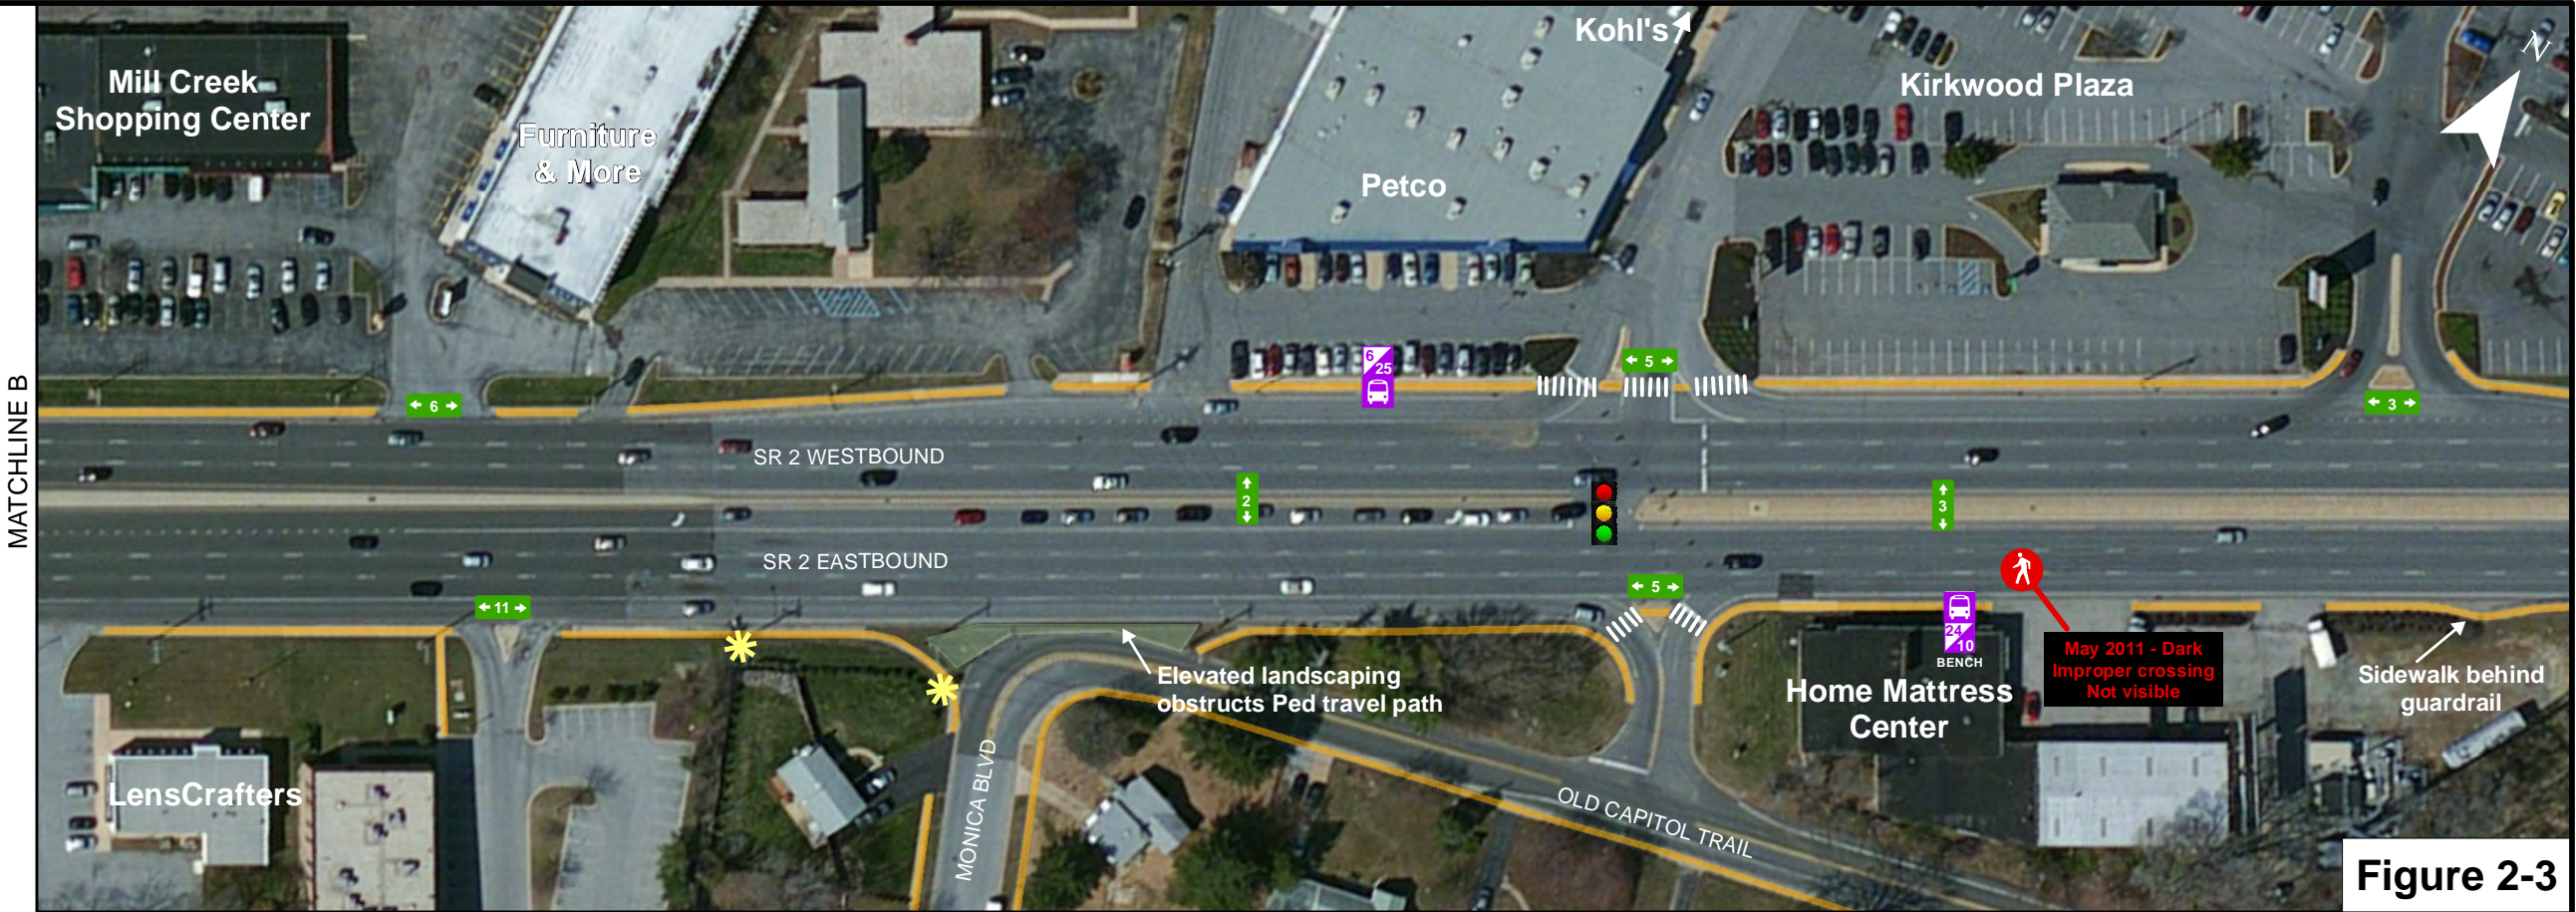
Figure 2-3

- Pedestrian Non-Injury Crash
- Bicycle Non-Injury Crash
- Pedestrian Injury Crash
- Bicycle Injury Crash
- Pedestrian Fatal Crash
- Bicycle Fatal Crash
- Dark Nighttime Crash
- Average Hourly Ped Volume (highest of 3 peaks)

Crash study period - January 2005  
through December 2012

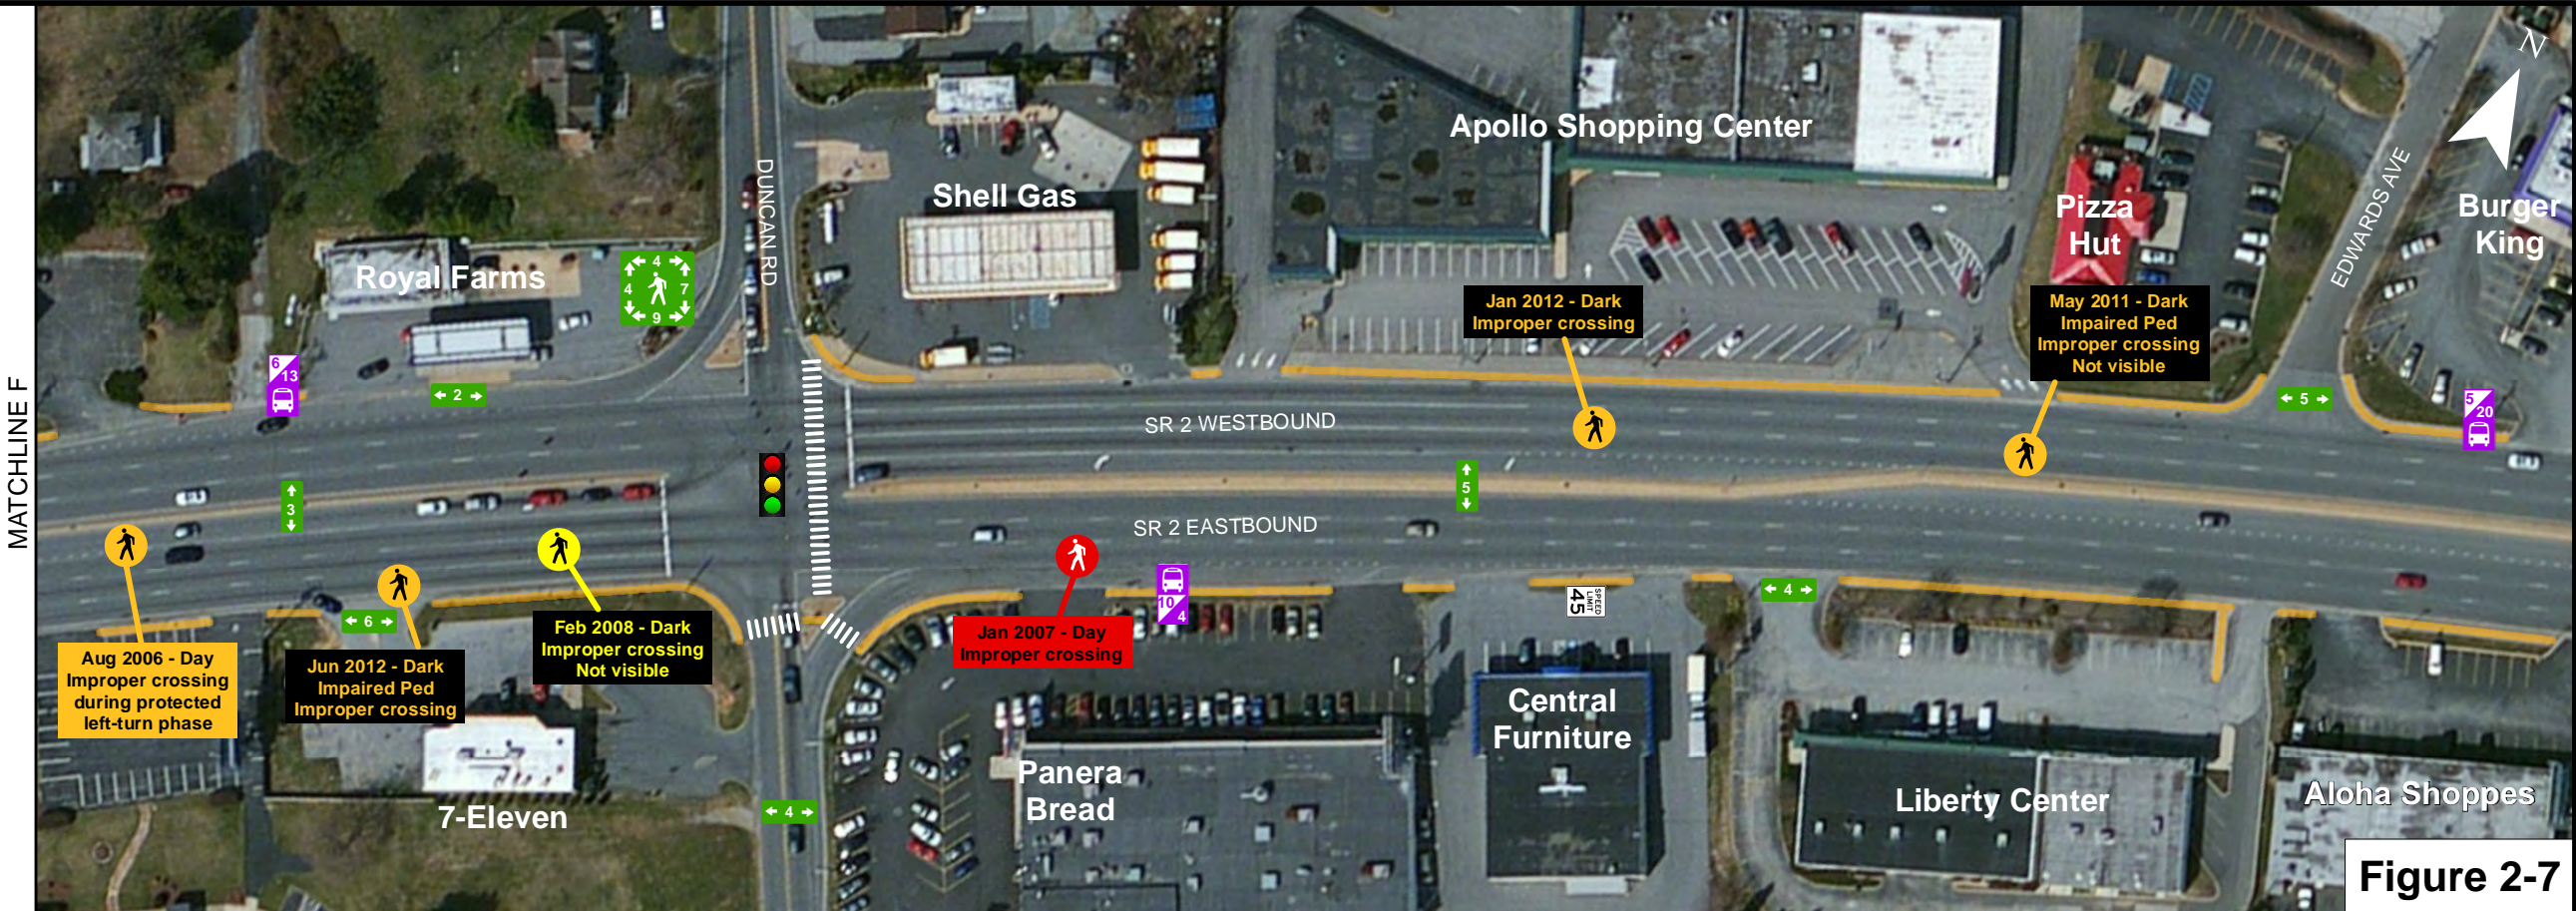
Figure 2-7

- Pedestrian Non-Injury Crash
- Bicycle Non-Injury Crash
- Pedestrian Injury Crash
- Bicycle Injury Crash
- Pedestrian Fatal Crash
- Bicycle Fatal Crash
- Dark Nighttime Crash
- Average Hourly Ped Volume (highest of 3 peaks)

Crash study period - January 2005  
through December 2012

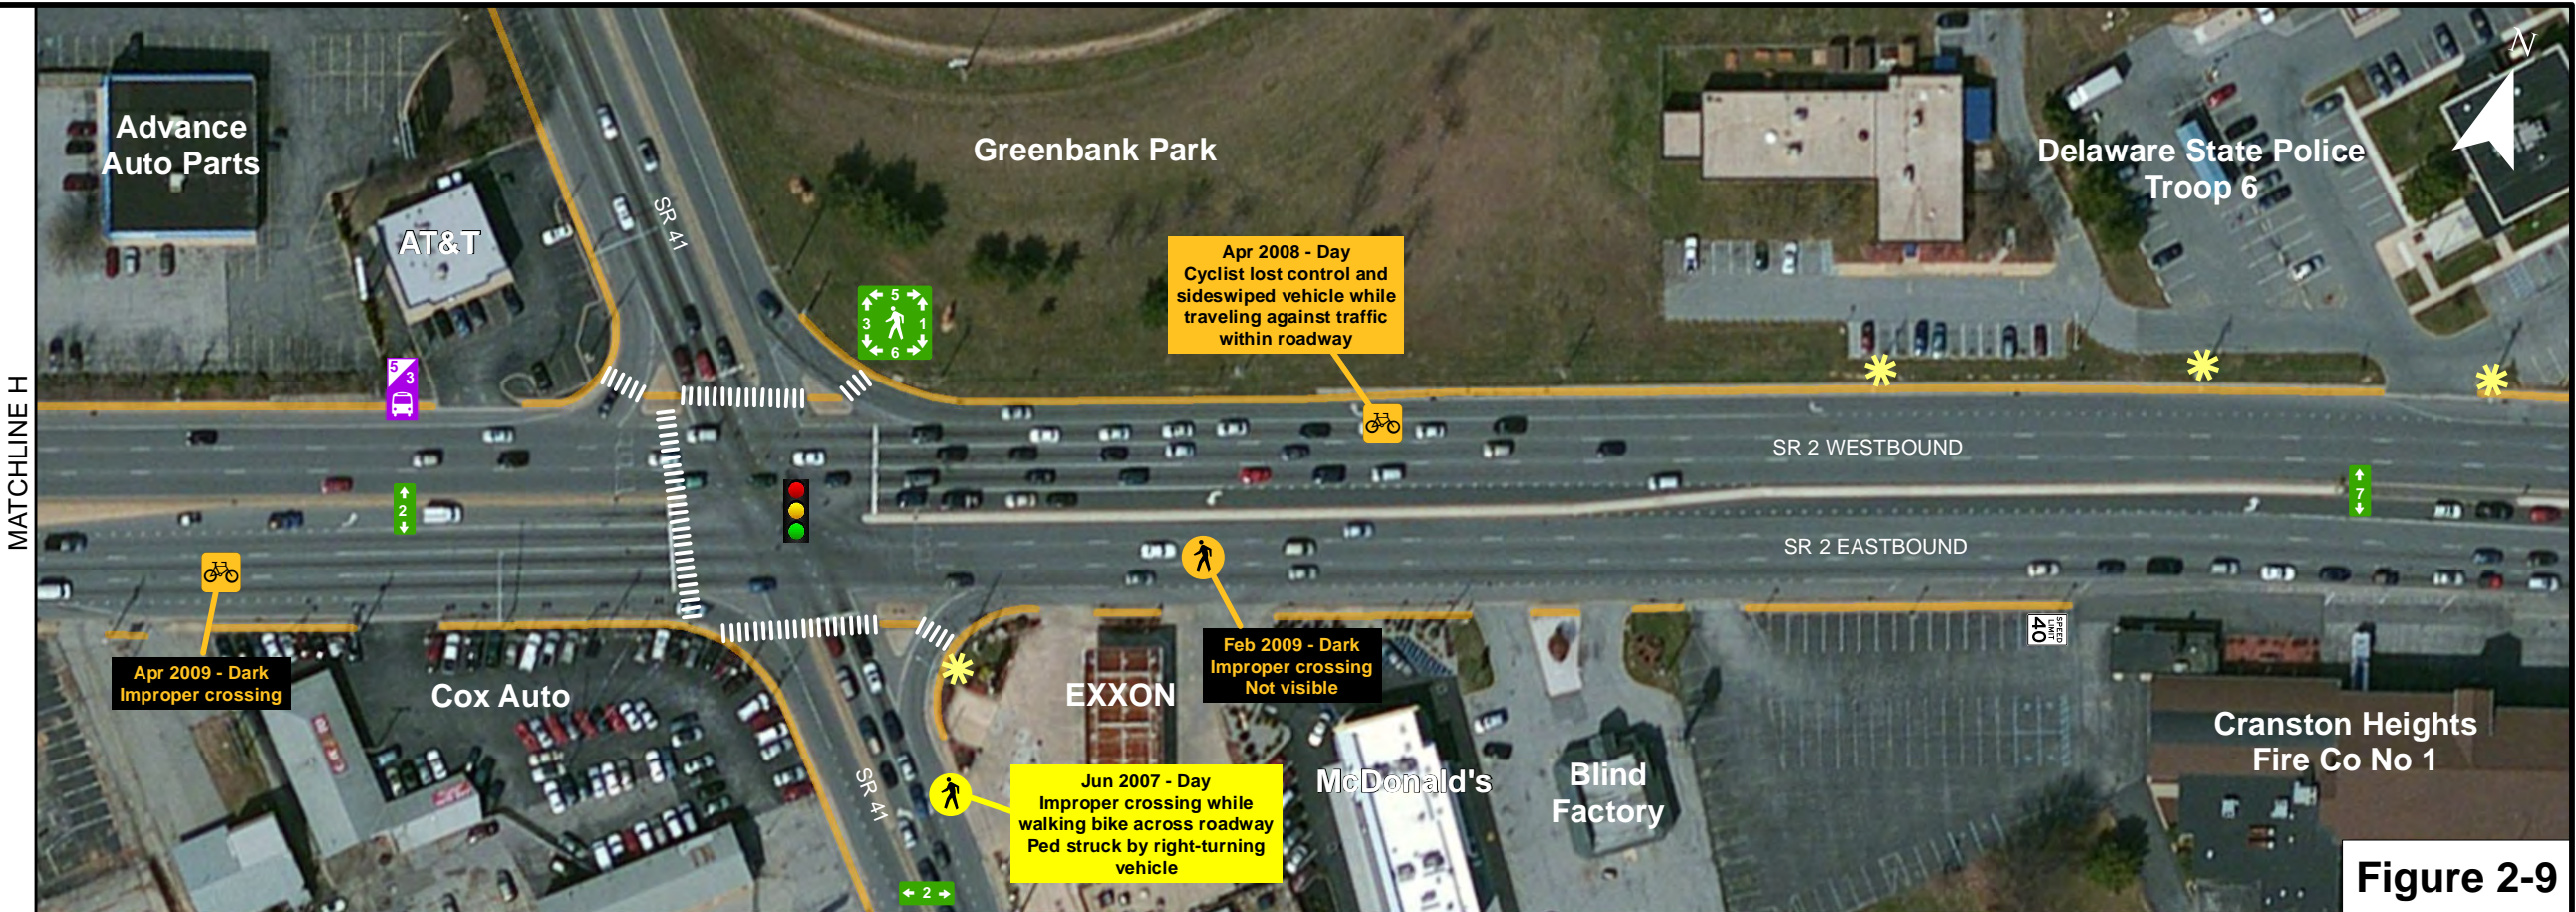
Figure 2-9

- Pedestrian Non-Injury Crash
- Bicycle Non-Injury Crash
- Pedestrian Injury Crash
- Bicycle Injury Crash
- Pedestrian Fatal Crash
- Bicycle Fatal Crash
- Dark Nighttime Crash
- Average Hourly Ped Volume (highest of 3 peaks)

Crash study period - January 2005  
through December 2012

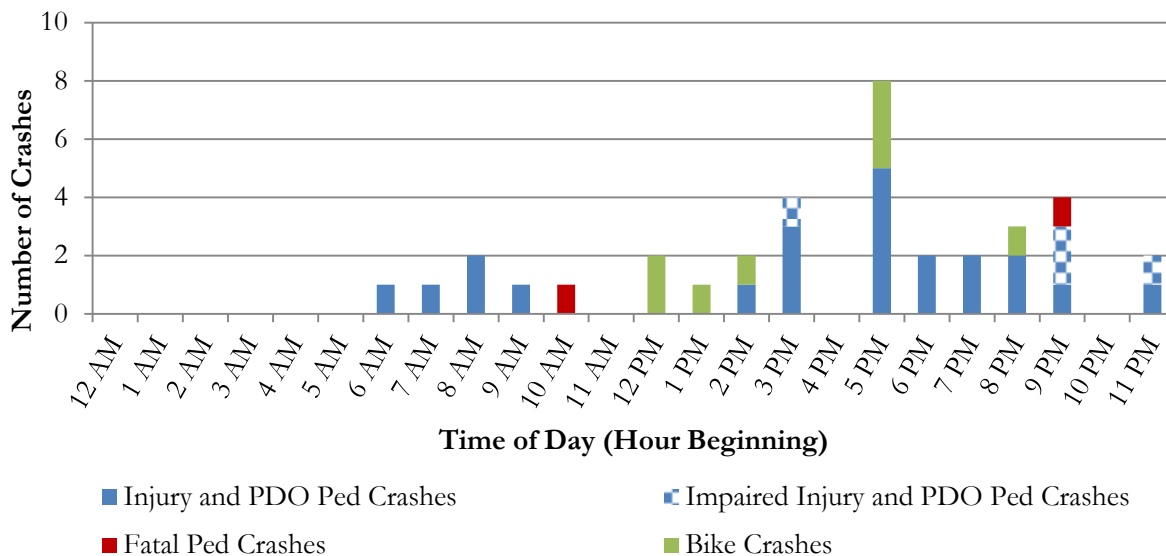
Figure 3-1 – SR 2, St. James Church Road to SR 141  
Pedestrian and Bicycle Crashes by Time of Day (Jan 2005 – Dec 2012)

***Pedestrian/Bicycle Crashes:*** A total of 28 pedestrian crashes and 8 bicycle crashes were reported during the eight-year study period from January 2005 through December 2012, including 2 fatal pedestrian crashes, 22 injury pedestrian crashes, and 7 injury bicycle crashes. All pedestrian and bicycle crashes during the study period were reviewed in detail and are summarized by location, lighting condition, and crash circumstances in **Figures 2-1 to 2-12**. Thirteen (46 percent) pedestrian crashes occurred at nighttime and one (13 percent) bicycle crash occurred at nighttime. Pedestrian and bicycle crash characteristics are summarized by time of day and impairment in **Figure 3-1**. As shown, 19 (53 percent) of the 36 total pedestrian and bicycle crashes occurred between 5 PM and 10 PM and 4 (11 percent) pedestrian and bicycle crashes involved an impaired pedestrian. **Figures 3-2 to 3-4** summarize pedestrian and bicycle crashes during the study period by the age of the pedestrian or bicyclist involved, year of the crash, and day of week, respectively. As shown, 7 (19 percent) crashes involved pedestrians/bicyclists between the ages of 46 and 55, pedestrian/bicycle crashes increased in 2008, and 11 (31 percent) pedestrian/bicycle crashes occurred on a Monday. Additionally, improper crossings resulted in 23 (82 percent) of the 28 total pedestrian crashes. Specifically, improper crossings between 6 PM and 7 AM resulted in 9 (32 percent) of the 28 total pedestrian crashes. **Table 1** summarizes pedestrian and bicycle crashes compared to the distance to signalized crosswalks across SR 2. As shown, the highest number of crashes per mile occurred along SR 2 between SR 7 and Farrand Drive; however, several of the crashes in this section occurred on the east leg of the SR 2 at SR 7 intersection. The next highest number of crashes per mile occurred along SR 2 between SR 41 and Albertson Boulevard, which is the shortest segment between signalized crosswalks. In addition, total crashes and total crashes per mile along SR 2 are shown by segment in **Table 1** for comparison purposes. As shown, the highest total number of crashes per mile coincides with the segments with the highest number of pedestrian and bicycle crashes per mile. Furthermore, 18 (64 percent) of the total 28 pedestrian crashes during the study period occurred within 200 feet of a signalized crosswalk and one (3.6 percent) crash occurred within a signalized crosswalk (crash occurred within the crosswalk on the north leg of SR 2 at Albertson Boulevard).

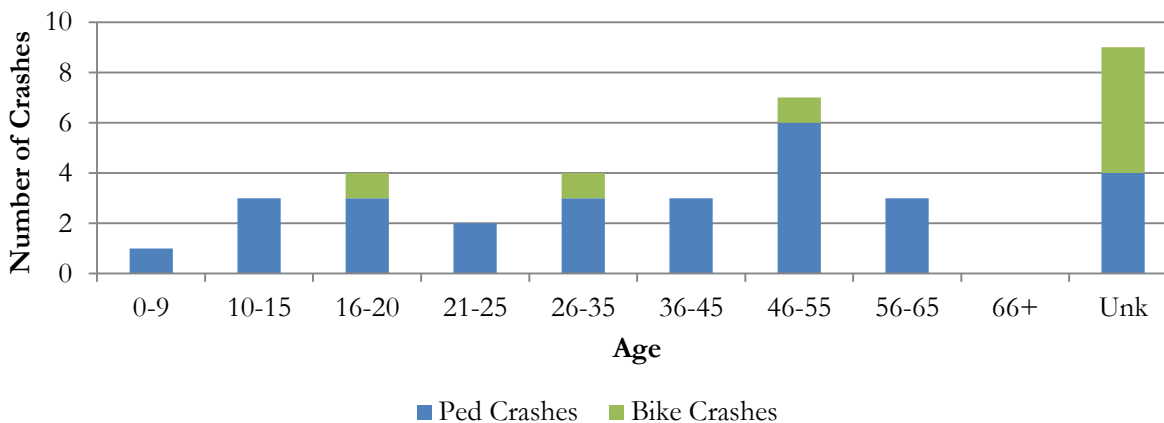
\* No reported pedestrian crashes that involved an impaired pedestrian resulted in a fatality  
 \*\* No reported bicycle crashes involved an impaired bicyclist or resulted in a fatality

Figure 3-2 – SR 2, St. James Church Road to SR 141  
Pedestrian and Bicycle Crashes by Age of Pedestrian/Bicyclist (Jan 2005 – Dec 2012)

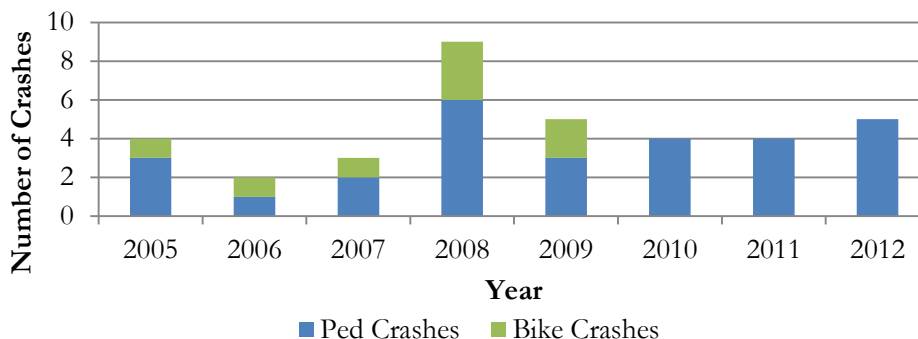
Figure 3-3 – SR 2, St. James Church Road to SR 141  
Pedestrian and Bicycle Crashes by Year

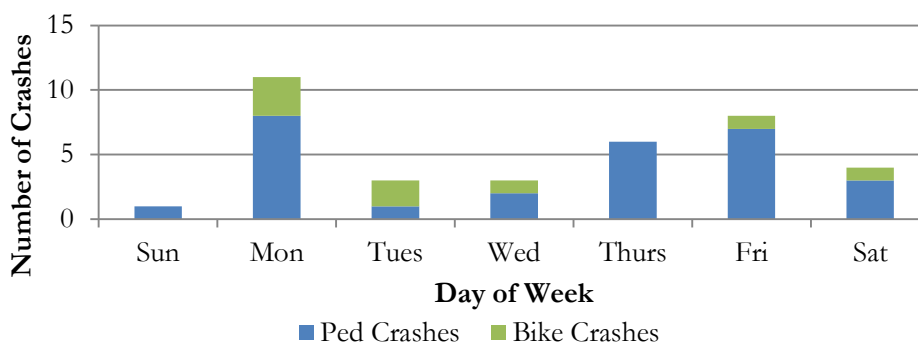
Figure 3-4 – SR 2, St. James Church Road to SR 141  
Pedestrian and Bicycle Crashes by Day of Week

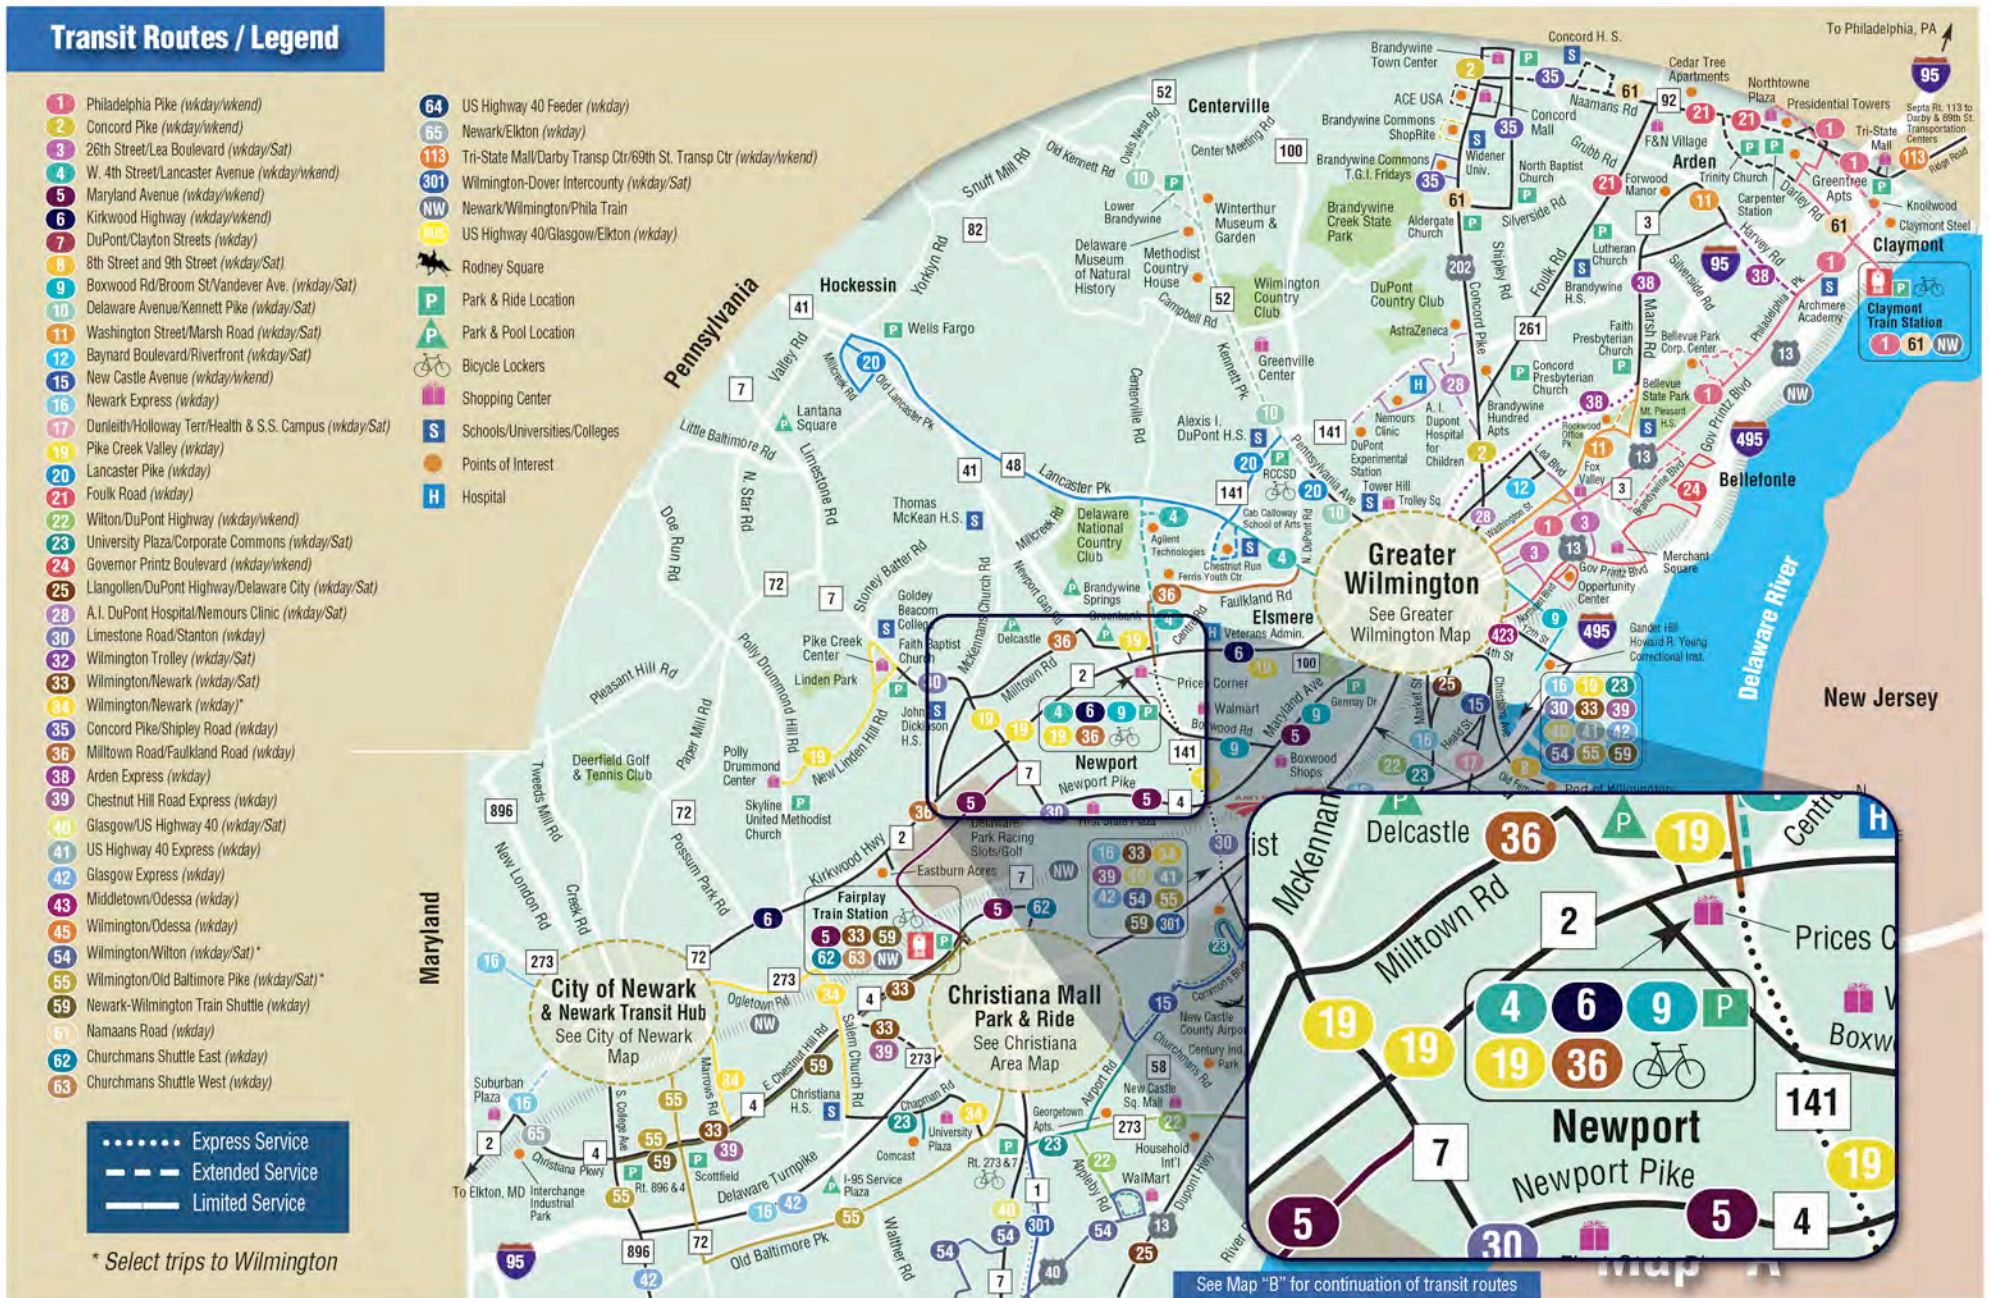
Figure 4 - Existing Transit Service along SR 2

Routing is subject to change based on rerouting due to construction or other circumstances that can only be addressed by altering the route temporarily or permanently.  
 For assistance with trip planning, call 1.800.652.DART or use the Google Trip Planner on DART's Home Page.

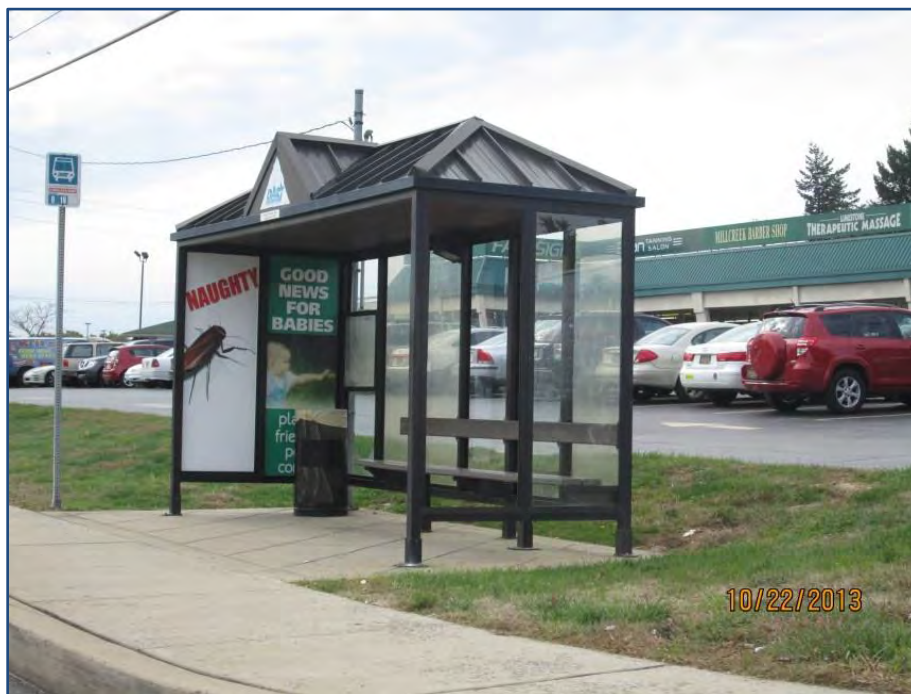
Photo 1 – Existing Bus Stop with Shelter along Westbound SR 2 east of SR 7  
(at Mill Creek Shopping Center)

- As noted in DTC’s *Bus Stop and Passenger Facilities Policy*, DTC prefers farside bus stop locations to facilitate bus re-entry into the traffic flow and minimize conflicts with right-turning vehicles and pedestrians crossing the intersection. Nearside bus stops may be considered on a case-by-case basis and it is very desirable to get bus operators’ input into the decision-making process. Delaware does not have any current laws requiring vehicles to yield to buses, thus DTC is generally reluctant to put bus stops on the near side of intersections unless there are compelling safety and/or operational advantages of a nearside location.

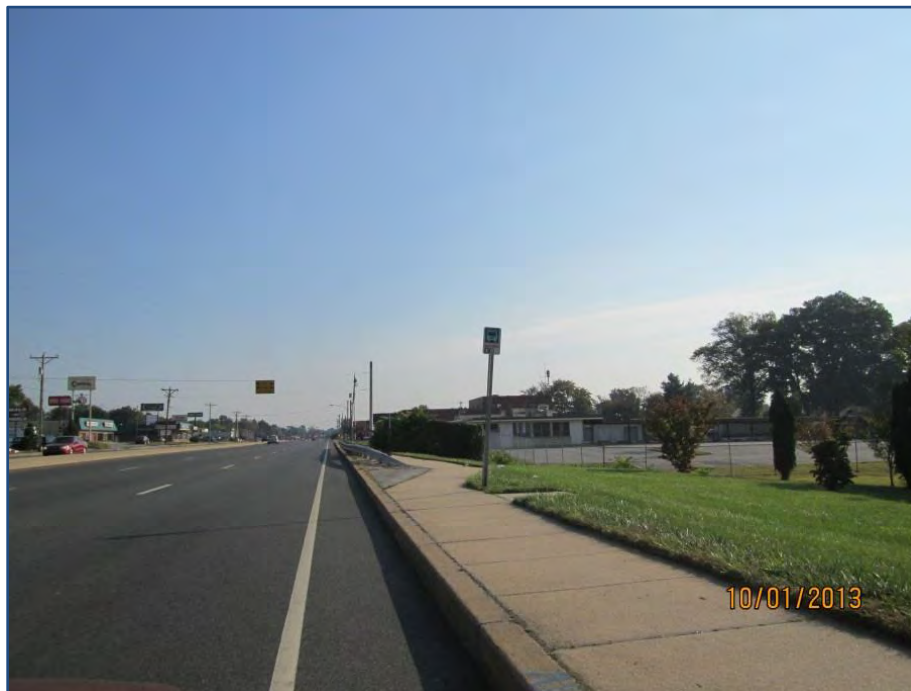
Photo 2 – Existing Bus Stop without Shelter along Eastbound SR 2 west of Evelyn Drive

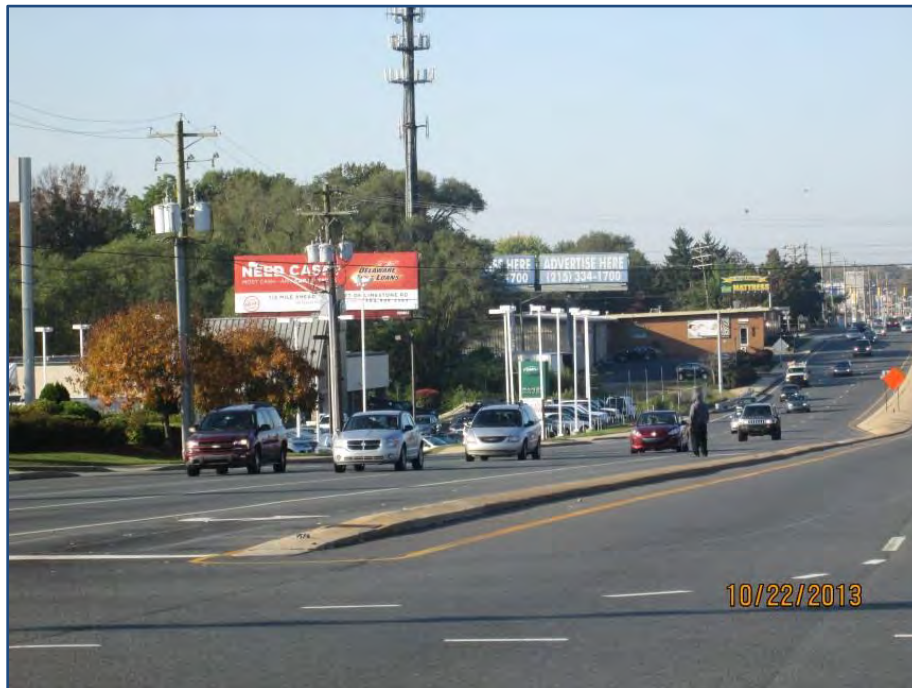
Photo 3 – Pedestrian Crossing SR 2 at Mid-Block Location west of Farrand Drive

**Mid-block Crossings:** Pedestrians were frequently observed crossing SR 2 at mid-block locations throughout the study corridor (see **Photo 3**). Pedestrians that cross at mid-block locations create a dangerous situation for both pedestrians and drivers – pedestrians may put themselves in danger if they misjudge the speed of approaching vehicles and the time it takes to safely cross the road; drivers may be startled and confused by an unexpected pedestrian crossing the road, causing the driver to slam on their brakes. According to the National Highway Traffic Safety Administration's (NHTSA) *National Pedestrian Crash Report* (June 2008), 78 percent of pedestrians killed were at non-intersection (i.e., mid-block) locations over the past decade. Based on field observations, pedestrians were frequently observed crossing SR 2 at mid-block locations within 200-feet of a marked, signalized crosswalk. During the September/October 2013 pedestrian observations, a relatively high volume (i.e., 5 or more pedestrians per hour) of mid-block crossings across SR 2 occurred at the following locations:

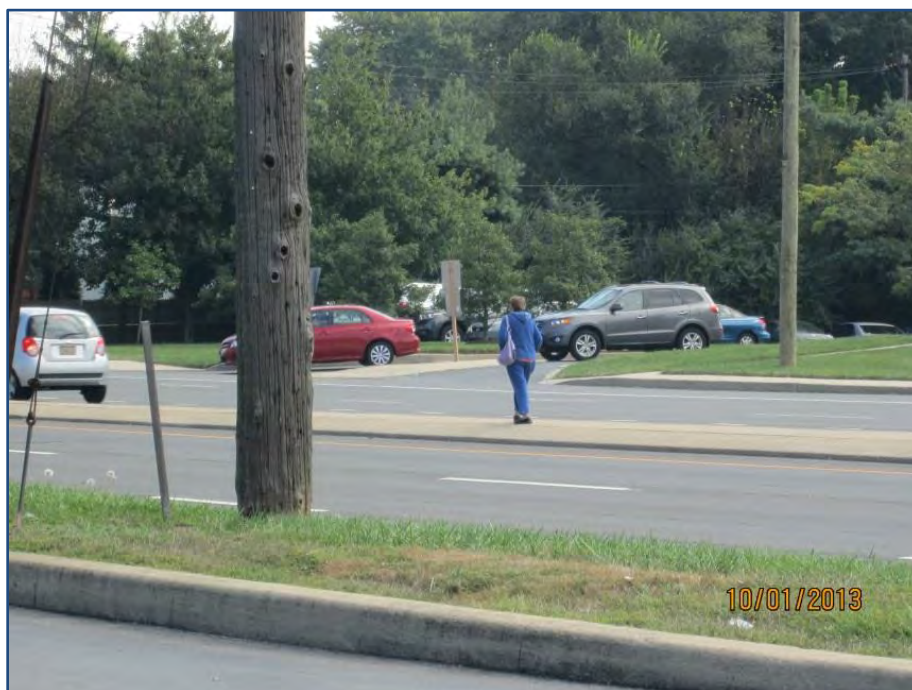
Photo 4 – Pedestrian Walking along SR 2 Median east of SR 7

**Waiting/Walking within the Median:** Due to the relatively heavy traffic volumes along SR 2, pedestrians crossing at midblock locations may experience significant delays waiting for acceptable gaps in traffic; therefore, pedestrians frequently perform two-stage crossings and wait within the median to minimize crossing delay (see **Photo 4**). Additionally, pedestrians waiting within the median were observed walking along the median while waiting to cross to the other side of the roadway, effectively treating the SR 2 median as a sidewalk. A wide median (i.e., approximately 10 feet or greater) is provided along SR 2 from east of St. James Church Road/Griffin Drive to west of SR 7, from Kirkwood Plaza to west of Farrand Drive, from west of Evelyn Drive to Woodhaven Drive, from the bridge west of SR 41 to the beginning of the eastbound left-turn lane at SR 41, from Albertson Boulevard to the Prices Corner entrance, and east of Centerville Road. In other areas, the raised concrete median is typically between 4 and 8 feet. Furthermore, the section of SR 2 from Greenbank Road to just west of SR 41 includes the bridge over Red Clay Creek – concrete barrier is provided within the median through this section, which prohibits pedestrians from crossing SR 2. Otherwise, there are no barriers provided within the median along SR 2 within the study limits. Currently, vegetation barriers (i.e., trees, grass, and small shrubbery) are provided along the SR 2 median in Elsmere (east of the study area).

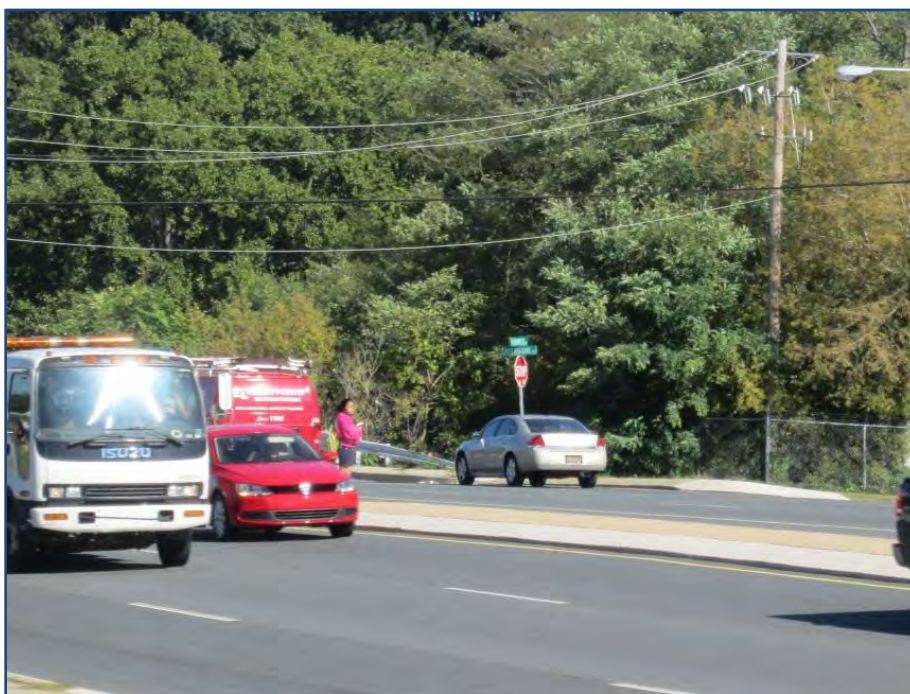
**Photo 5 – Student Crossing SR 2 near Greenbank Road**

Young children/students were observed (see **Photo 5**) walking along and crossing SR 2 from approximately Greenbank Road to Duncan Road to access the Anna P. Mote Elementary School (2110 Edwards Avenue). The nearest marked crosswalks across SR 2 are at Duncan Road and SR 41, which are located approximately 1,050 feet and 1,600 feet west of and east of Greenbank Road, respectively.

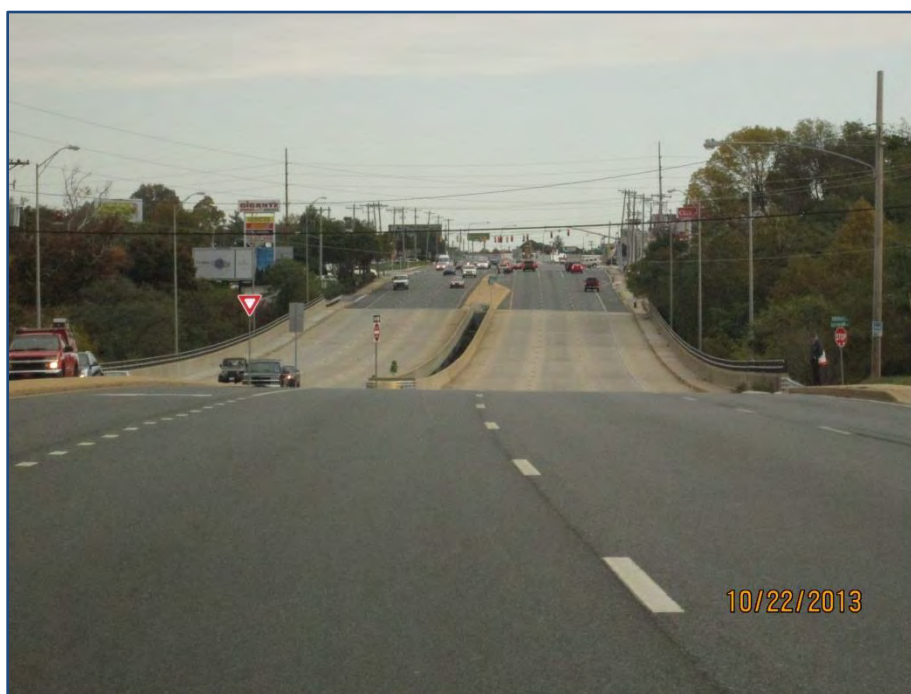
Vehicular travel speeds were measured at four locations along eastbound and westbound SR 2 between St. James Church Road/Griffin Drive and SR 141. Vehicular speeds were measured using radar during off-peak periods between 9 and 11 AM and 1 and 3 PM on Tuesday, September 24, 2013 and Wednesday, September 25, 2013. Within the study limits, the posted speed limit is 45 miles per hour west of Albertson Boulevard and 40 miles per hour east of Albertson Boulevard. As shown in **Table 4**, 85<sup>th</sup>-percentile speeds on eastbound and westbound SR 2 do not exceed 5 miles per hour above the posted speed limit at locations west of SR 7, in the vicinity of Evelyn Drive, and west of SR 141. However, the 85<sup>th</sup>-percentile speeds on eastbound and westbound SR 2 east of Greenbank Road are 7 miles per hour above the 45-mph posted speed limit. It should be noted that the section of SR 2 from Greenbank Road to just west of SR 41 includes the bridge over Red Clay Creek (i.e., a change in character from the primarily commercial areas along the rest of the study corridor as shown in **Photo 6**), which may be contributing to higher speeds. However, pedestrians cannot cross SR 2 over the barrier in this section (two separate bridges are provided – one for each direction; concrete barrier is provided within the median).

Photo 6 – SR 2 over Red Clay Creek (west of SR 41)
